A progressive **Archaeological Survey and Monitoring** of the Combined Sewer Overflow Control Facility, Ross's Landing Park, Chattanooga, Tennessee. The sponsor of the December 11 and 12, 1990, archaeological testing program was the City of Chattanooga. Sampling of the site was necessary to determine the extent of the CSO trenching during construction, at which time logistical considerations pertaining to continued park use could be met.

The Jeffrey L. Brown Institute of Archaeology
The University of Tennessee at Chattanooga

March 1993

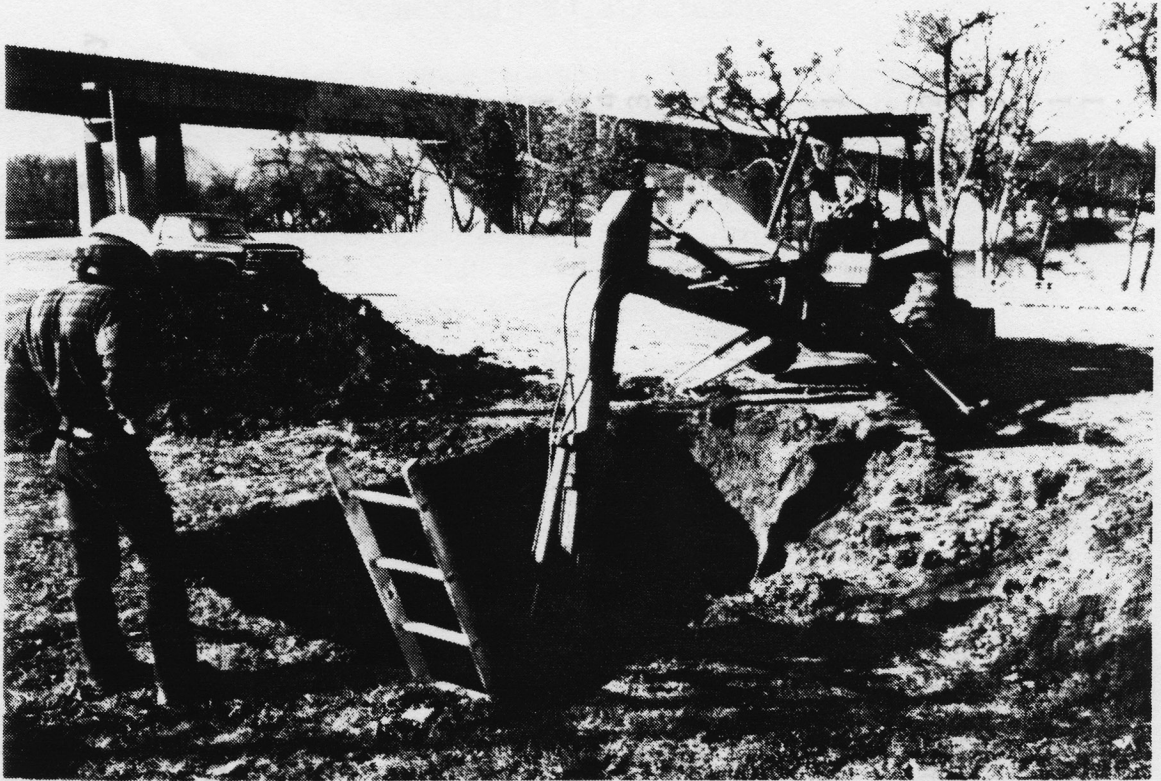
Figure 4. Backhoe testing prior to construction. Deep machine-assisted testing in December, 1990, confirmed the presence of industrial deposits filling the ravine that passed through the project area prior to the late 1880s.

Two of the test trenches, designated A and B, were situated west of the marina at the west end of the park, and near the egress point of the proposed combined sewer. Trenches C and D were placed adjacent to Riverfront Parkway at points east of the Olgiate Bridge overpass (Figure 4).

No features (structures, footings, etc.) of the early historic or prehistoric periods were noted in the tests, but artifacts from both periods were recovered. Trench C appears to have intercepted an early historic-period natural drainage ravine or gulley that was obliterated by municipal filling in the 1880s. Much of this fill appears to have been waste products from the major industrial tenant of the property, the Loomis and Hart Company.

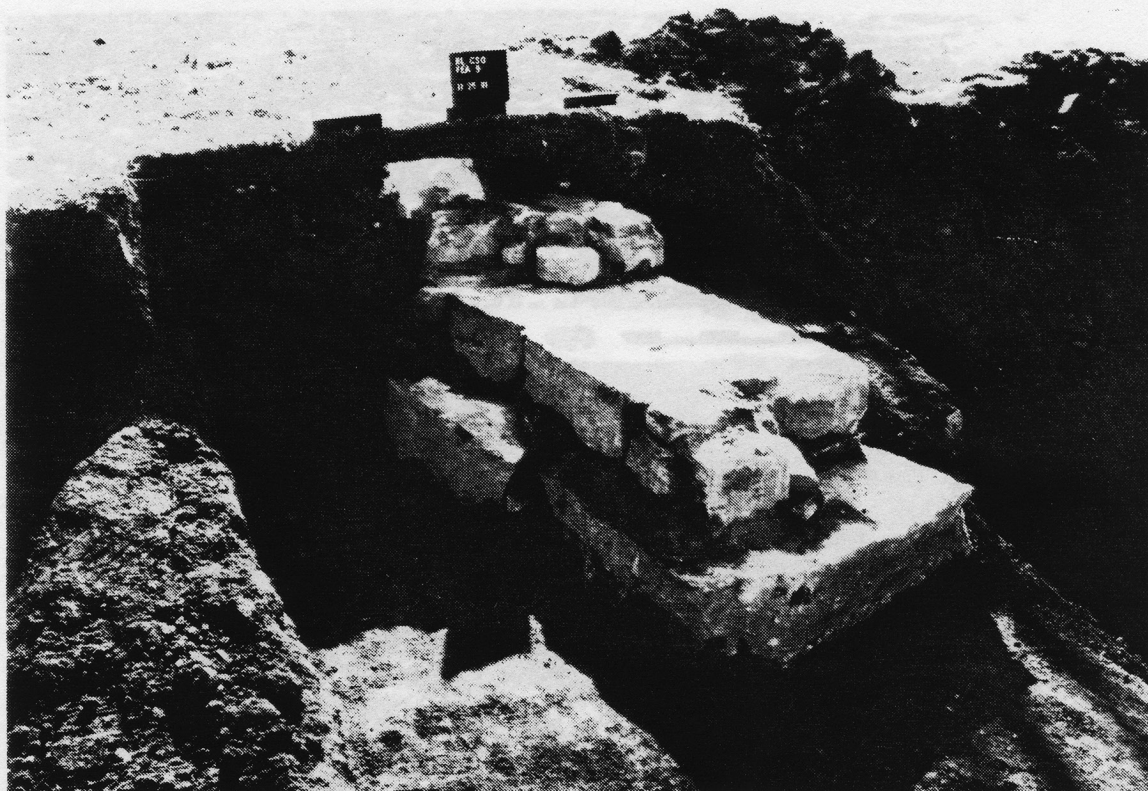
Figure 6. Feature 9, a limestone foundation probably associated with the Lookout Water Company pumping station erected in the early 1870s.
